**SUMMARY REPORT ON ENVIRONMENTAL MONITORING**

**TIDAL POWER DEMONSTRATION PROJECT**

**AT RACE ROCKS ECOLOGICAL RESERVE**

**FINAL REPORT**

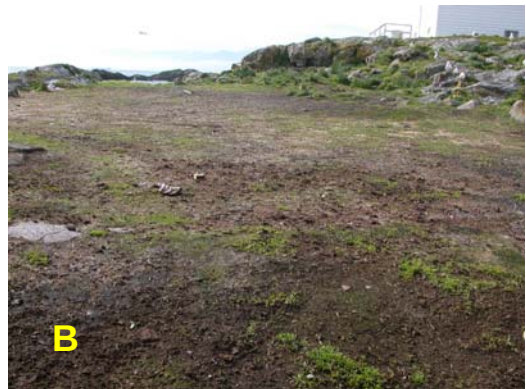
2. Impacts to upland vegetation (compaction, smothering, die off) from sea lion haul out (winter) in the proposed construction area were visible (Photo B). Spring growth of terrestrial plants in this area typically occurs once the sea lions vacate, therefore impacts from the proposed construction activity in April were considered very low.

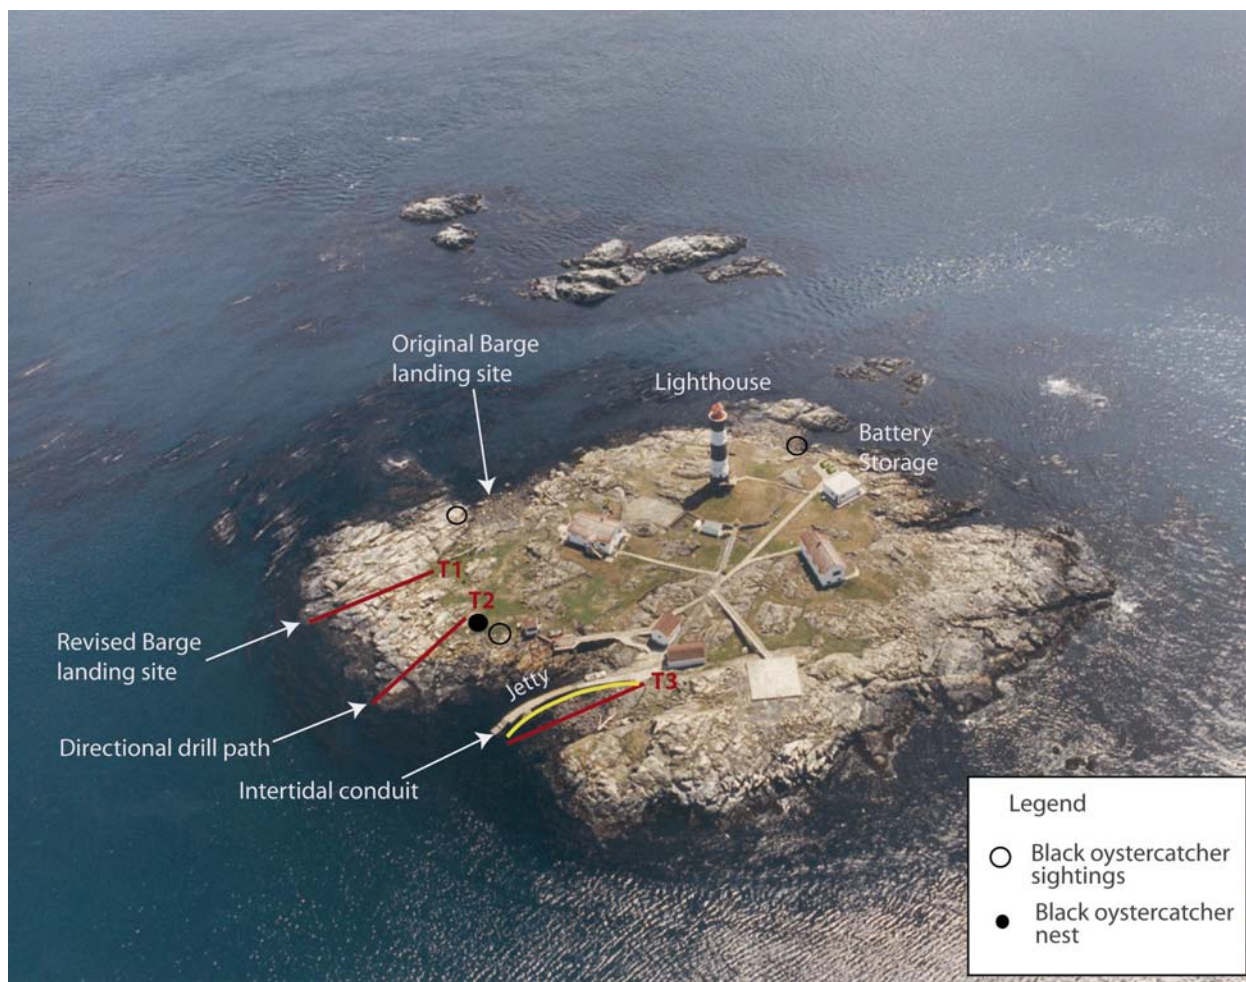
**Figure 2. Location of intertidal transects (T1 – T3) and black oystercatcher sightings and nest.**

Figure 2 shows the location of the intertidal transects (T1 and T2), and the oystercatcher nest.

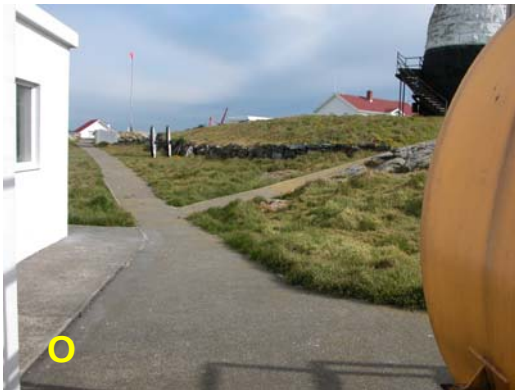
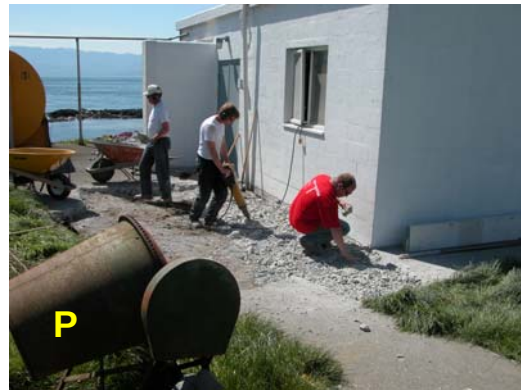
Photos O-P show the generator room prior to construction and during sidewalk demolition. Demolition debris from the sidewalk was stockpiled on the concrete pad seaward to the demolition area (Photo Q). The concrete mixer was placed in the middle of the demolished sidewalk, where run off was contained in a localized area during cement mixing activity. Construction material was also stockpiled on the grass immediately adjacent to the generator room, with a barrier placed between the vegetation and material to minimize potential impacts. Finer material was covered to prevent dispersion into terrestrial seabird nesting areas or into the marine environment (Photo R).

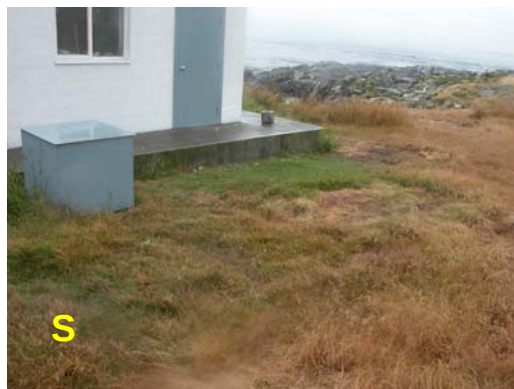
Photo S shows the completed generator (battery storage) room with construction materials in the surrounding area removed. Impact to the surrounding vegetation was very low (temporary smothering) and full recovery was anticipated. Gulls with chicks remained present in the upland area adjacent the generator room as did oystercatchers and Pigeon guillemots on the bedrock within the intertidal zone seaward of the generator room.

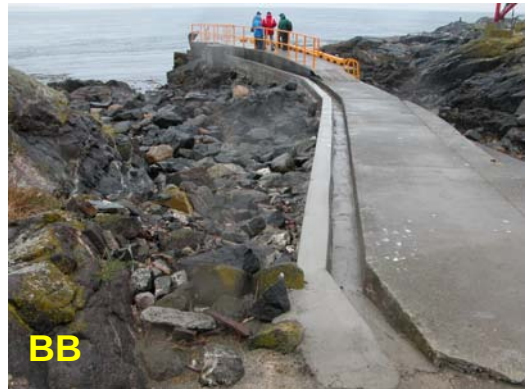
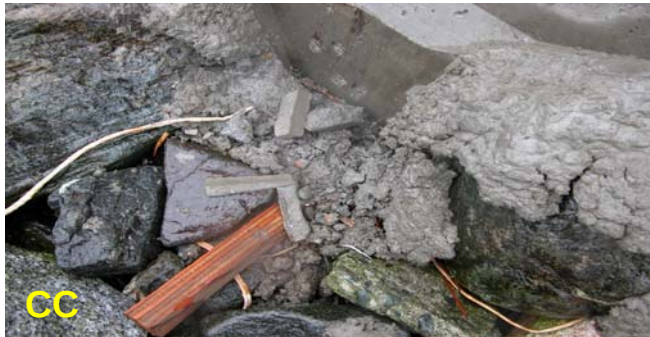
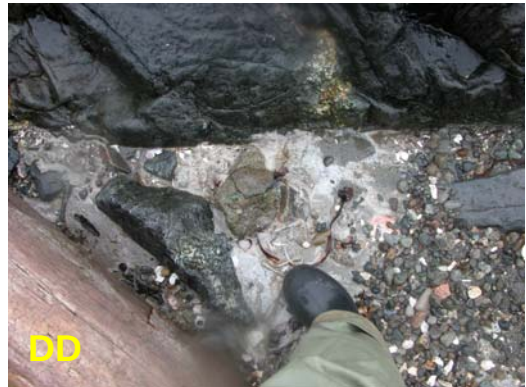
An inspection of the intertidal zone after construction was completed on July 8, 2005. Photo BB shows the completed concrete encasement along the jetty. Although rapid colonization of algal vegetation on the concrete structure was anticipated in the lower intertidal zone, only a diatomaceous film had grown on the lower portion of the concrete trough to date. Impacts to the immediate area were contained within 2.5m of the jetty and consisted of a few patches of concrete rubble (Photo CC), which were subsequently removed upon request. In the immediate upper intertidal zone on the east side of the jetty where the concrete mixer was located, a small 1m X 0.20m area of concrete runoff was observed (Photo DD); however, there was no impact to sensitive or critical habitat.

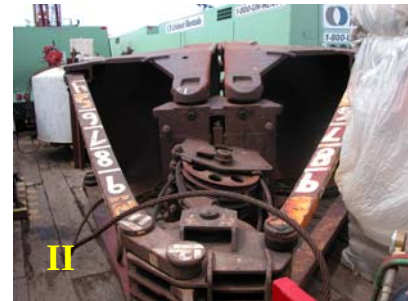
The clamshell dredge used to remove overburden (primarily boulder and cobble) from the pile site was a 3 cubic yard bucket (Photo II, marking in feet) weighing about 7000 kilograms and covering an area of approximately 1 x 3m when opened. The clamshell was used three times during the pile installation. The initial area of impact from the dredge spoils was anticipated to be approximately 10 – 15m<sup>2</sup>.

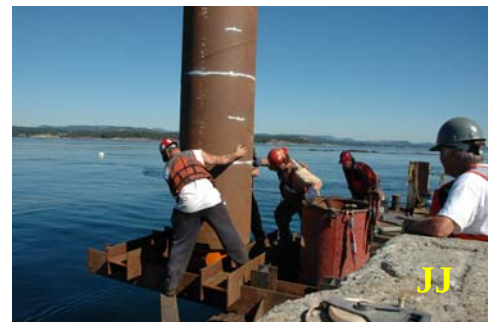
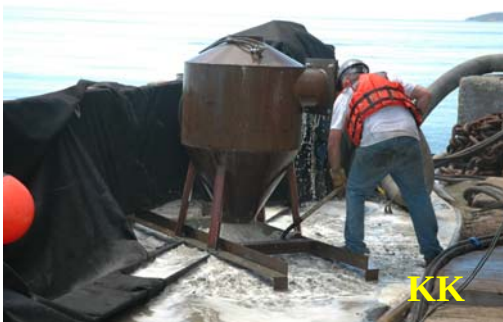
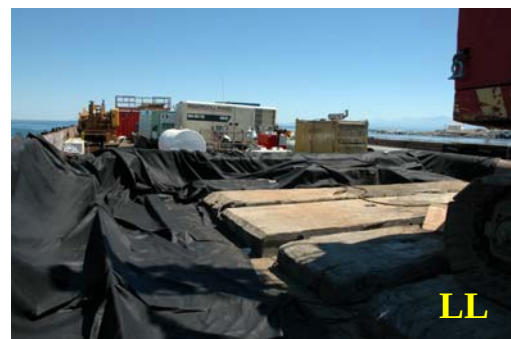
Following the positioning of the barge on July 16 (see monitoring observations in Section 3.2.3.1) the drill (in the caisson) was positioned on the bow (Photo JJ) and the cyclone (Photo KK), used to separate overburden material from drill effluent (water and fines), and filter cloth were set up on the deck of the barge (Photo KK, LL). Drilling activity started on July 21 and continued on July 24-25 following replacement of one of the compressors. Due to the collapse of the caisson and damage to the drill, the remaining drill activity took place August 2-4, 2006, after a replacement drill was located and installed.

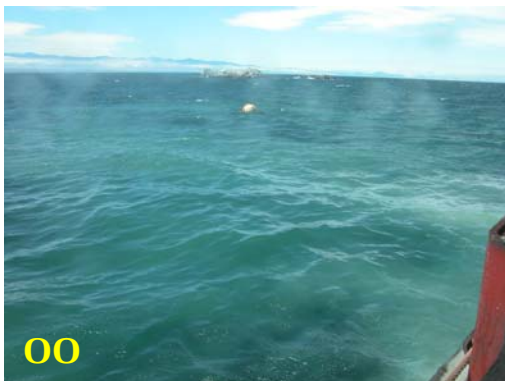
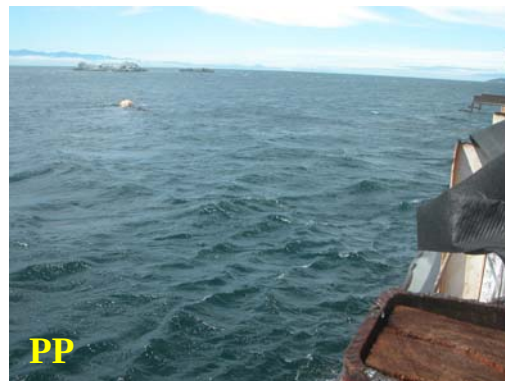
- A larger sediment plume was visible off the bow of the barge during a slack tide (Photo OO); however the sediment plume dissipated rapidly (within 35 minutes) (Photo PP) following a tide change.
- Filter cloth was functioning as intended in that only fines were observed in the drill effluent discharge.
- Harbour seals hauled out on the nearby islets did not appear to be impacted from the drilling activity in that seal behaviour did not change (e.g., moving from an islet to the water, head lifting) at any time during the observations of the drilling and effluent discharge activities.

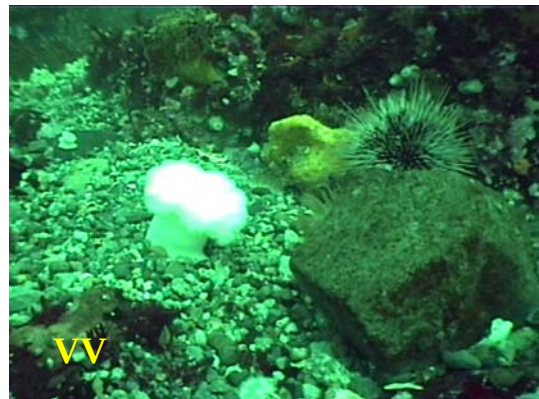
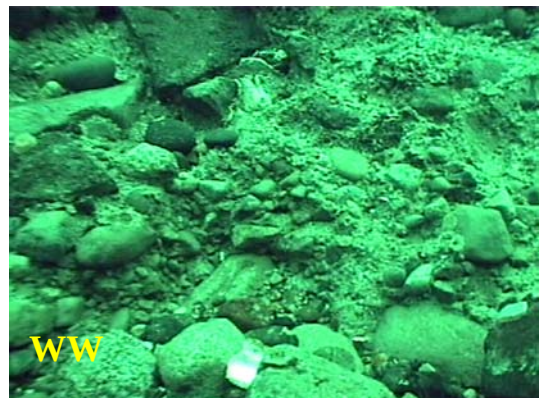
- A transition area between the pile location and non-impacted seabed where material (pebble and cobble) from the dredge spoil is dispersed over the natural seabed (Photo VV). This area extends approximately 20m east along the cable route and west along the direction of tidal flow.
- Settlement of *Epiactis* (brooding anemone) and *Metridium* on exposed bedrock and cobble.
- Some areas of exposed clay embedded with cobble and pebble on the north slope of the excavation area (Photo WW, close view).

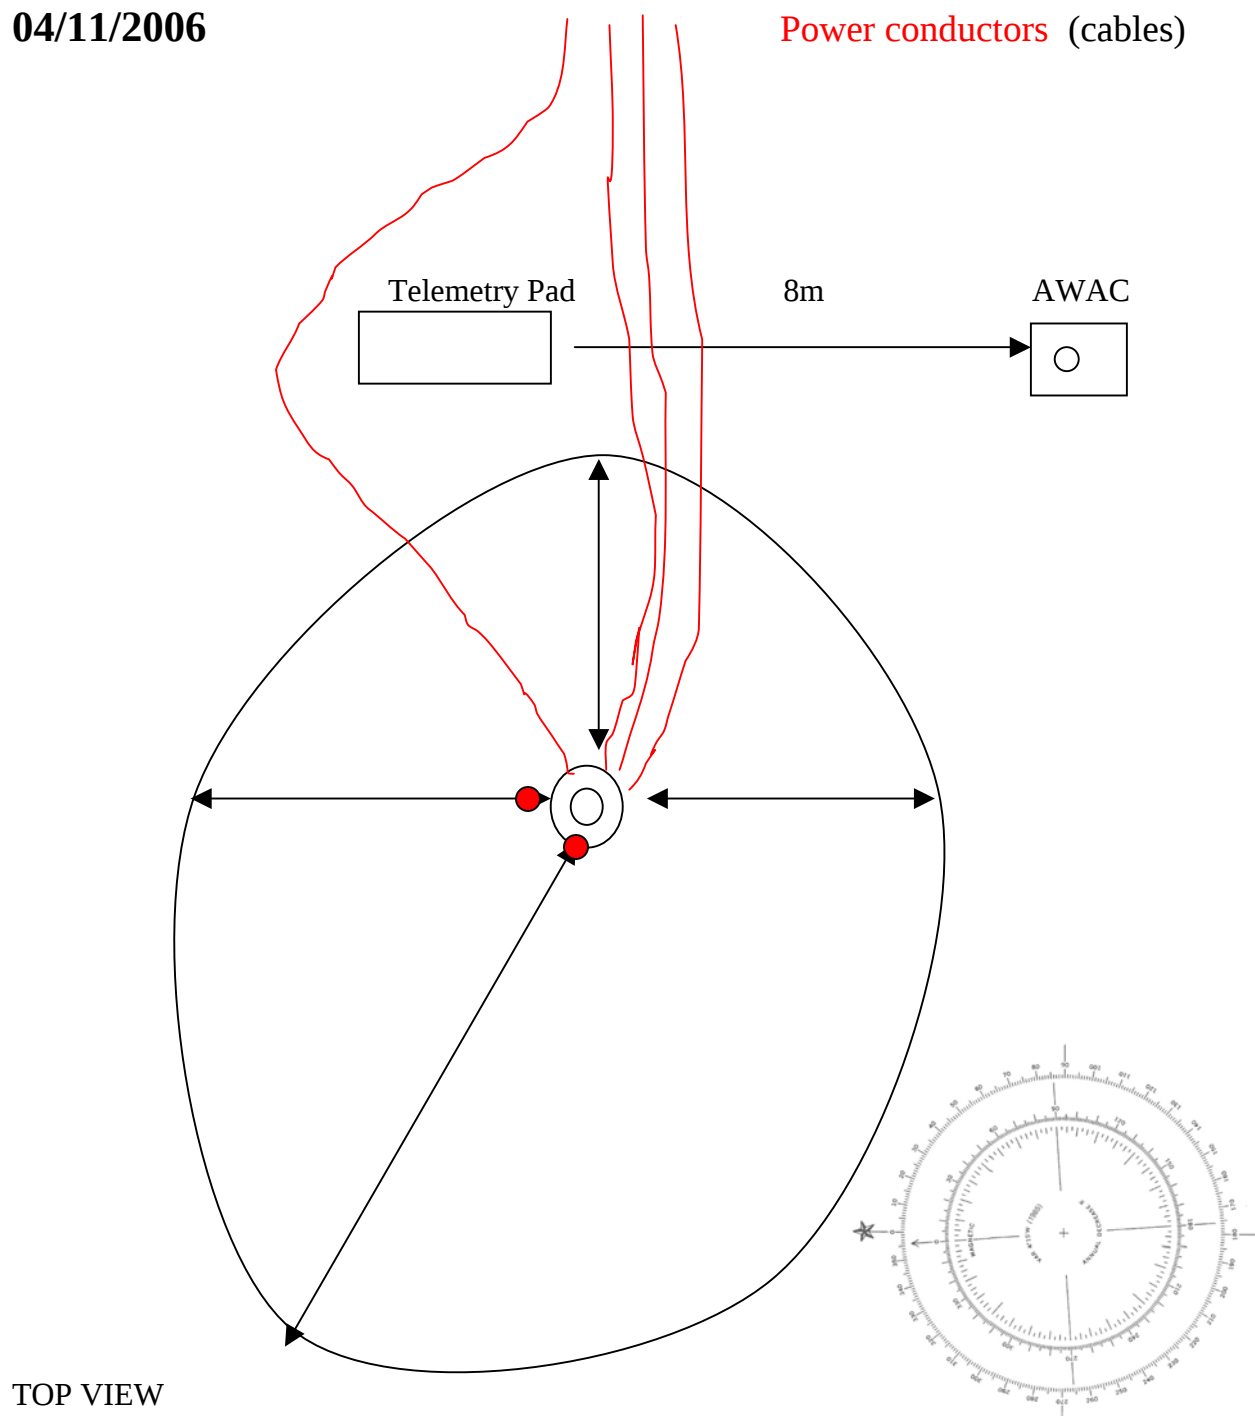
**TURBINE SITE LAYOUT**

TOP VIEW

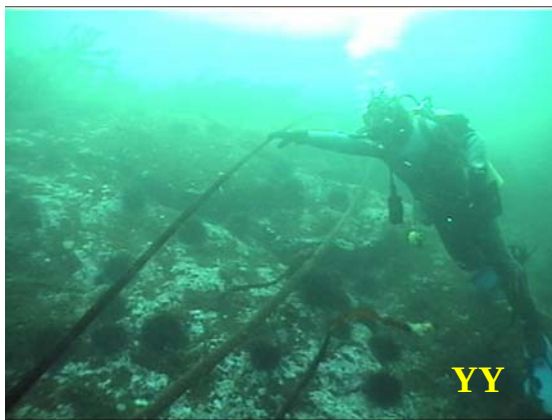
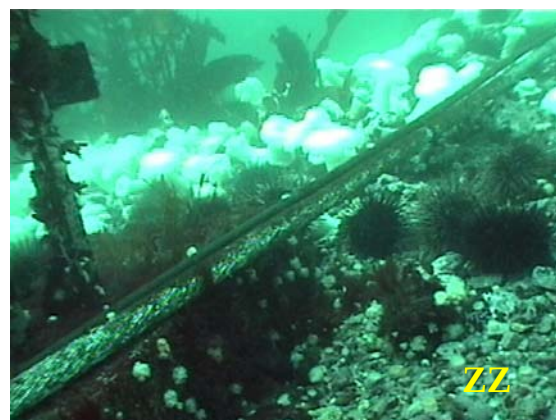
- At various locations along the cable route, the cables were separated from each other at distances greater than could be observed due to the visibility conditions (approximately 10m);
- Near the jetty, the fibre optic line attached to a cable “billowed” at several locations (Photo YY showing separation; Photo ZZ showing bundled power and fibre optic cables);

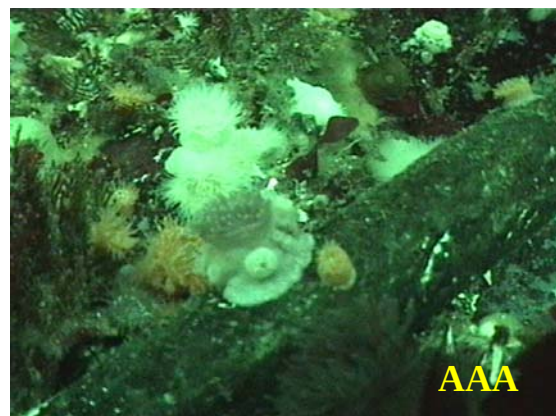
- *Epiactis* (brooding anemone) were present on the cable in a number of locations (Photo AAA).

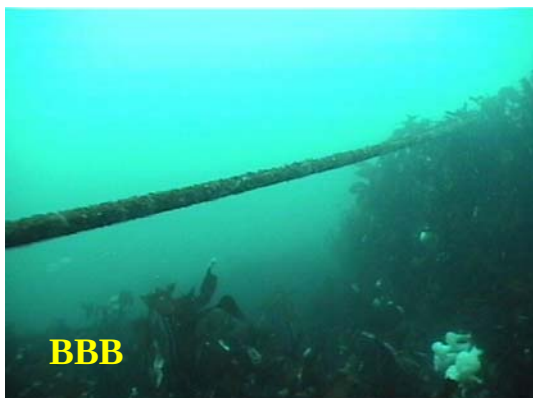
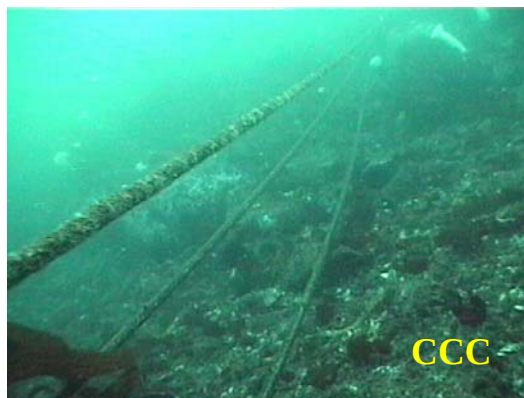
- Several of the cables observed remained off the bottom for a large percent of the length of the cable (30 – 50%) (Photo BBB, CCC).

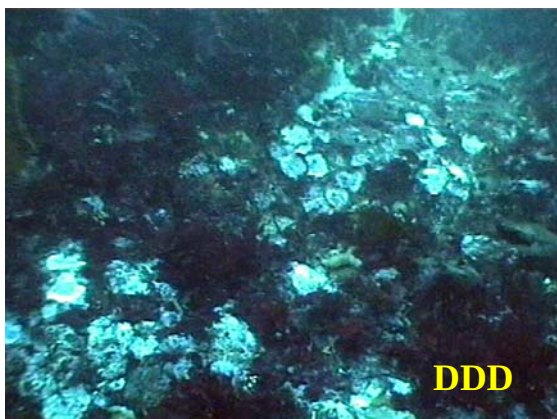
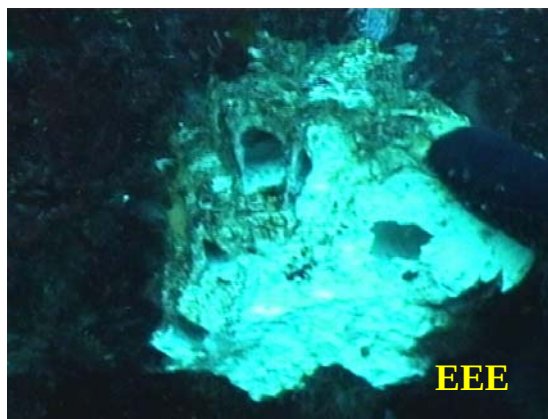
- The impact was in a very localized area and was restricted to *B. nubilus*. There was no visible impact to vegetation or other sensitive invertebrate species (e.g., sponges, hydrocorals).

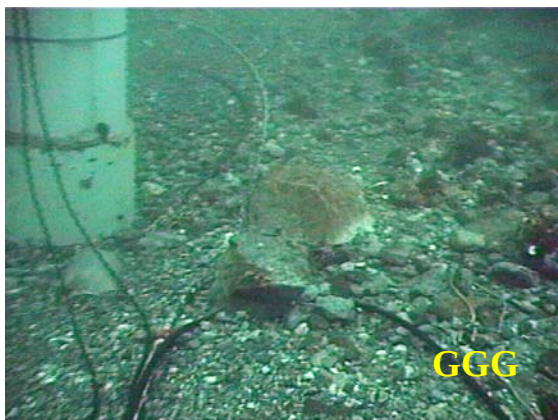
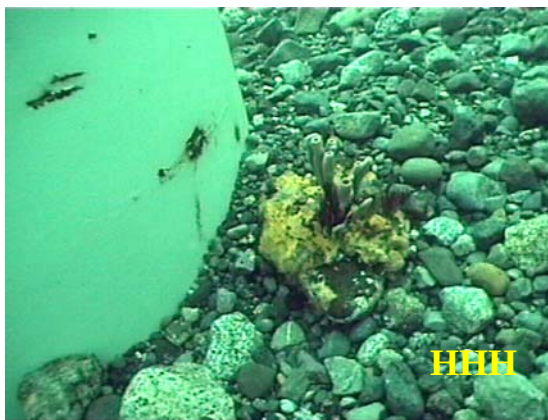
- Use of the protruding rock immediately north (Photo GGG) or west (Photo HHH, with sponge) of the turbine (see Figure 9) to document sediment movement and composition. The base of the pile could be incrementally marked at the base and used to measure material deposition or erosion. Invertebrate colonization on the rock could also be documented (counts or percent cover by species) during the same quarterly monitoring period.

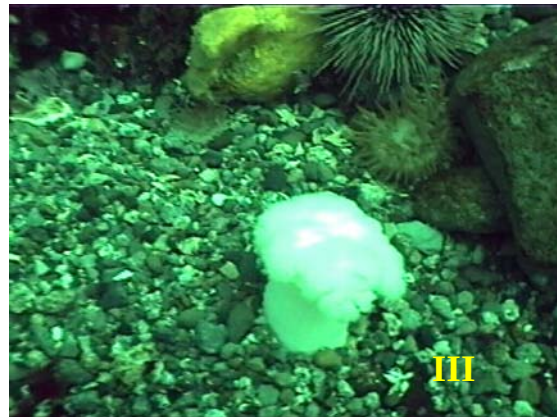
- Choice of one site within the dredge spoil area south of the pile that could be easily marked, to document recovery of the seabed (substrate and biota) over time (quarterly on an annual basis). The focus would be to document the movement of dredge material that currently smothers a portion of the seabed (Phoh III, base of *Metridium* buried) and the re-colonization rate of sessile and mobile invertebrate species.
