# **Assessment of fish and wildlife presence near two river instream energy conversion devices in the Kvichak River, Alaska in 2014**

December 2014

Matthew J. Nemeth, Justin T. Priest, and Heather M. Patterson

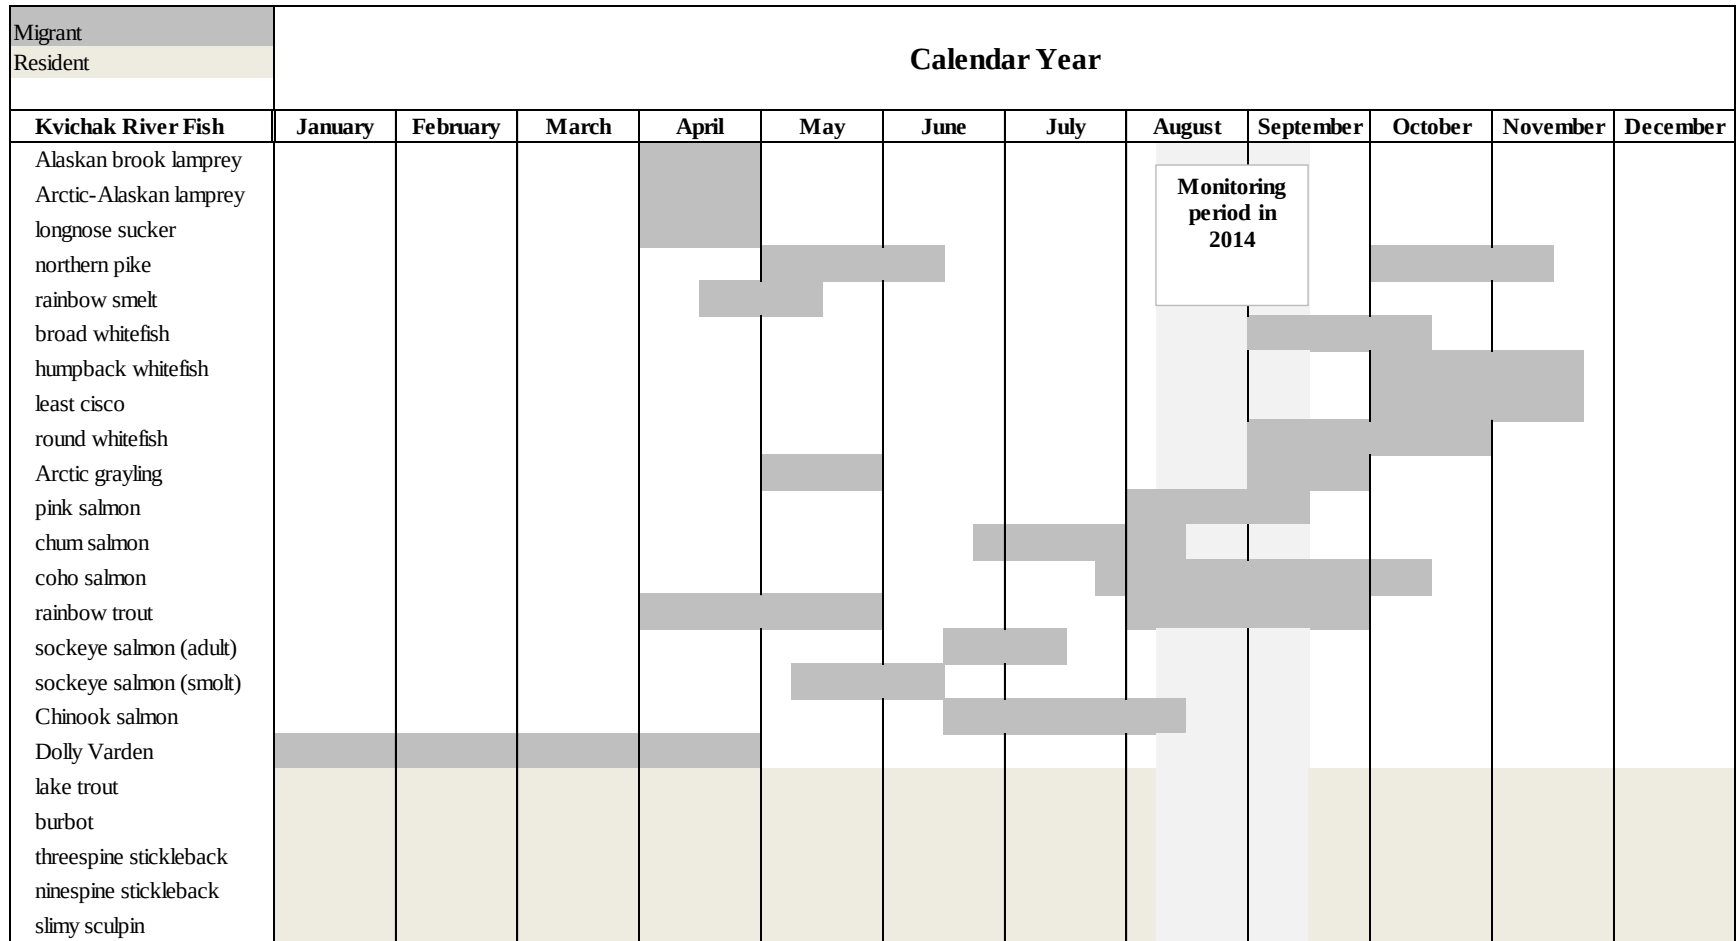
Figure 2. Approximate temporal peaks in fish presence, by species, in the Kvichak River near Igiugig relative to the 2014 monitoring period of August 13 – September 10 (multiple sources; see Table 1).

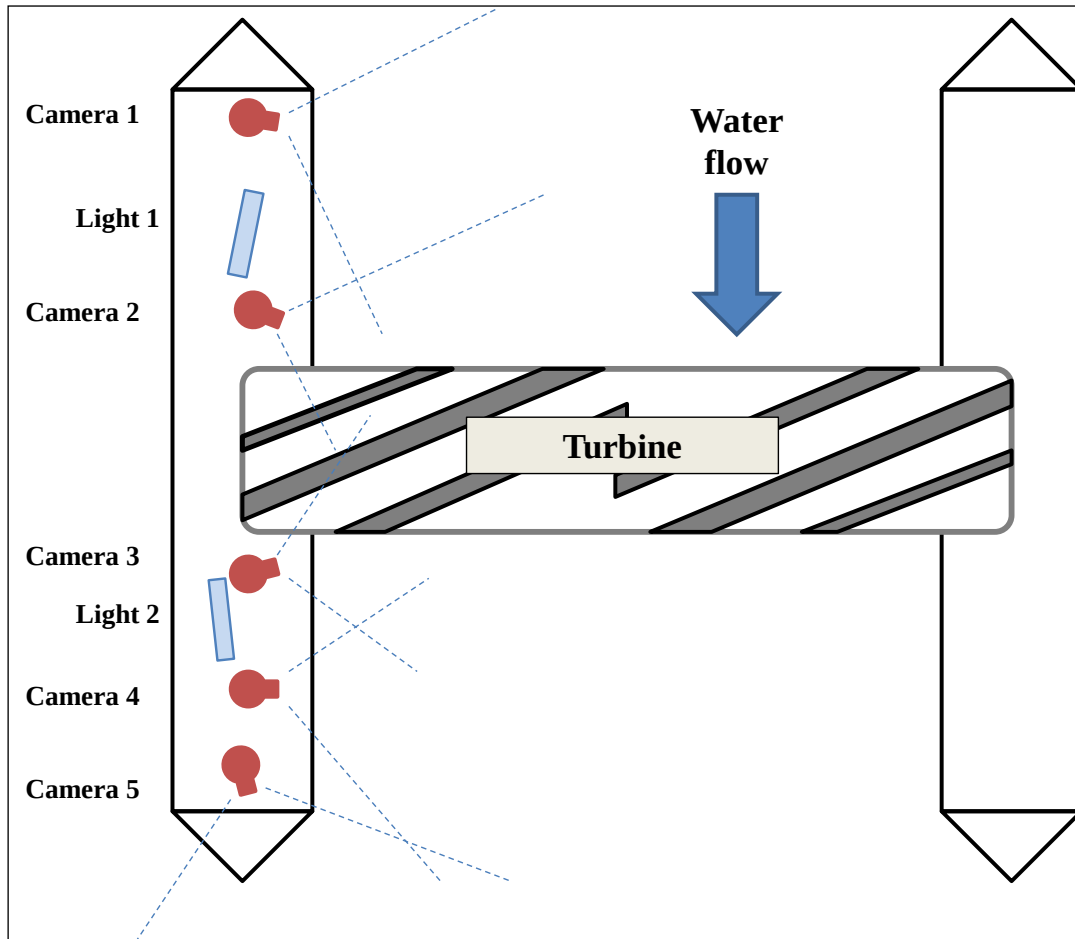
Figure 3. Schematic of ORPC device once submerged, showing final location of cameras and lights along the port side pontoon of the device. Dashed lines model the field of view from each camera. Schematic is not to scale.

Five cameras and two lights were used to monitor the ORPC device (Figure 3; Photo 1). Two cameras and one light were used to monitor the BRI device (Figure 4; Photo 2). Cameras and lights were affixed directly to the devices.

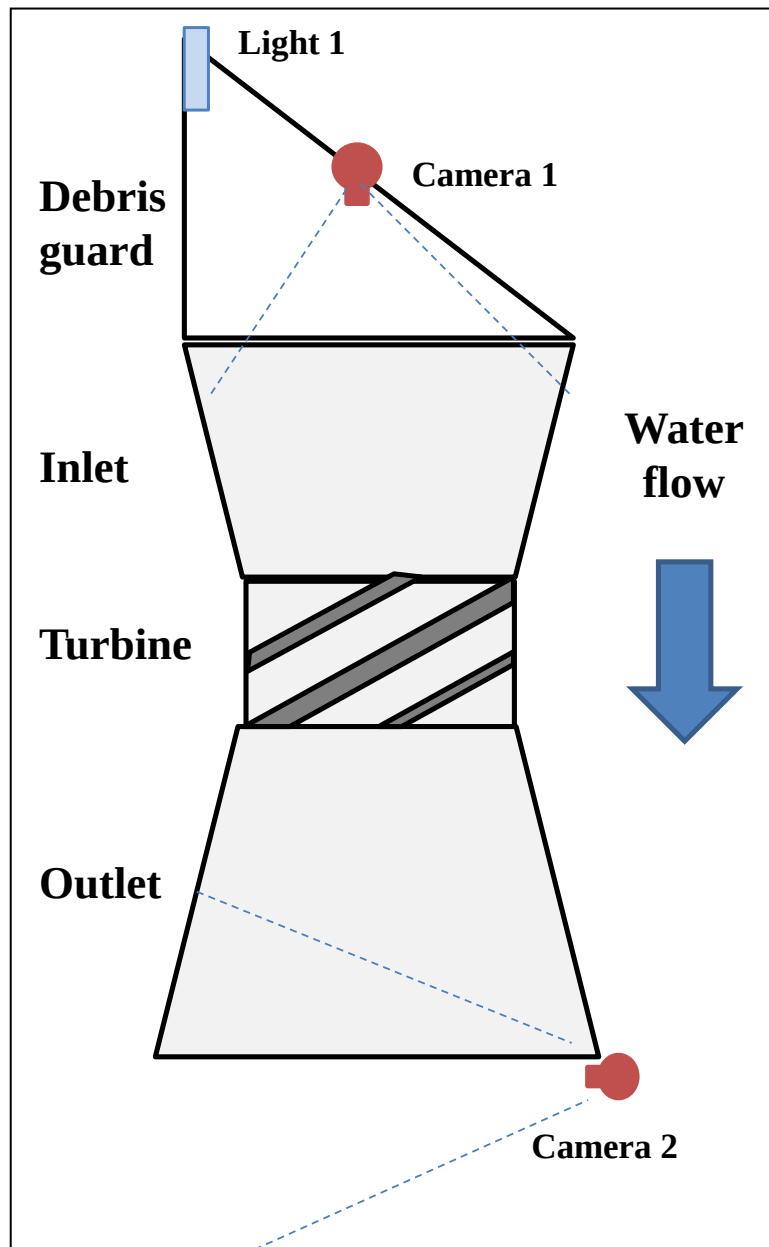
Figure 4. Schematic of BRI device once submerged, showing final location of cameras and lights. Dashed lines model the field of view from each camera. Schematic is not to scale.

At the BRI device, Camera 2 had a view of the substrate for the first 3-5 m downstream of the device.

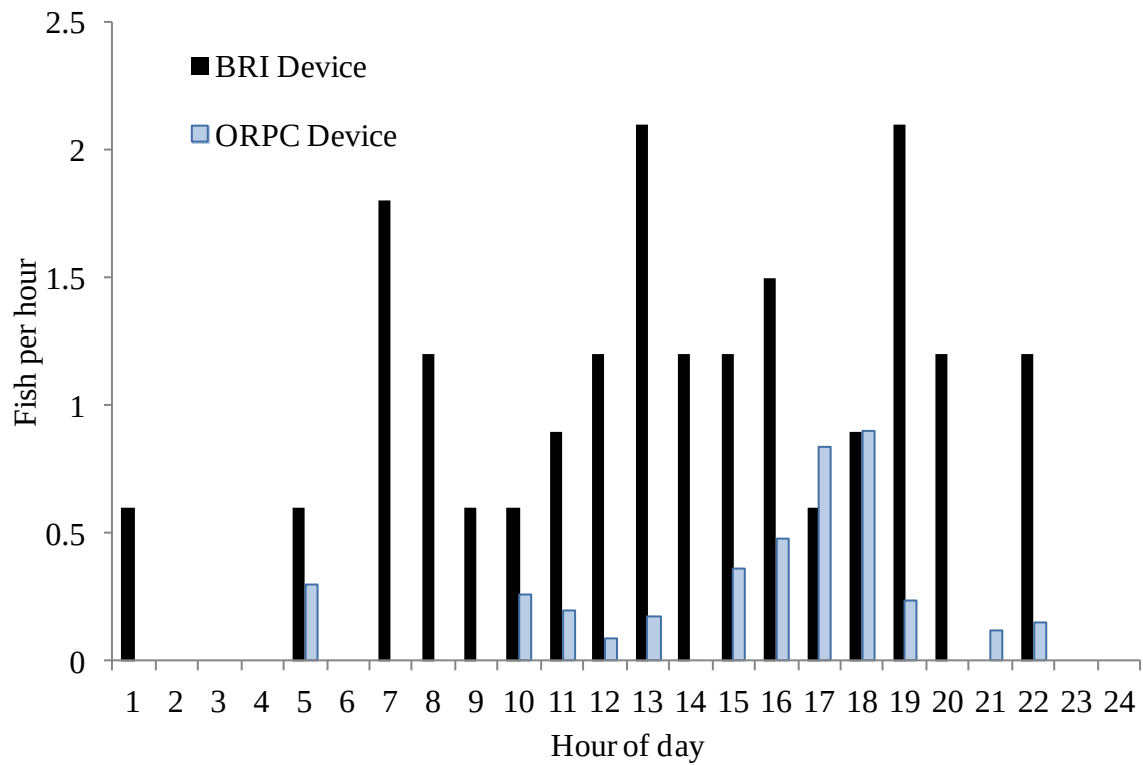
Figure 5. Fish detections by hour of the day at each RISEC device, standardized for review effort.

After standardizing for effort, sightings translated to 0.09 fish per hourly block at the device (52 fish divided by 555 hourly blocks among all cameras combined; Table 2). Sightings peaked between 1600 and 1800, accounting for over half of the sighting rate (Figure 5).

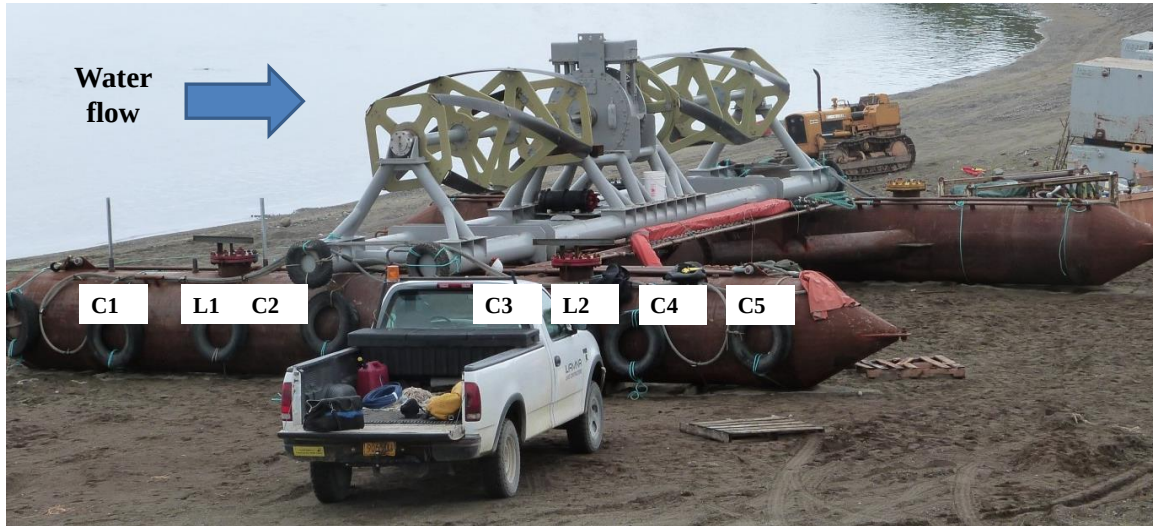
Photo 1. ORPC device before deployment, showing approximate mount locations of underwater cameras (C1 – C5) and lights (L1 – L2) in 2014. Water would flow from left to right.

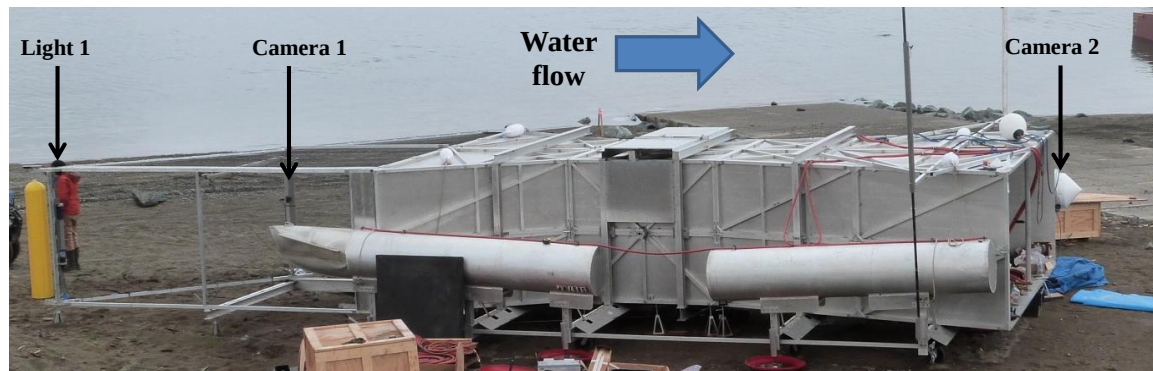
Photo 2. BRI device before deployment, showing mount locations of underwater cameras and light used during deployment in 2014. Water would flow from left to right.

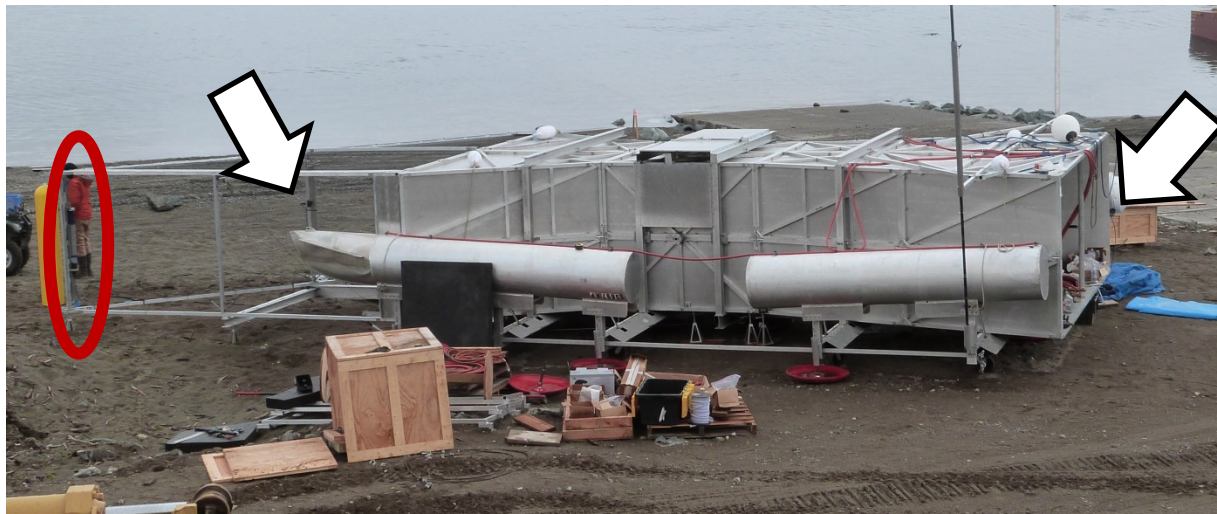
Figure 1. Location of mounts for two cameras (white arrows) and one light (red oval) on the BRI device. Water would flow from left to right.
