SeaGen Environmental Monitoring Programme: Biannual Update.

Version 5

Covers environmental monitoring June 2005 – November 2008.

Document title	SeaGen Biannual EMP update
Document short title	EMP undate (February 2009)
Status	Version 5
Date	12th February 2009
Project name	
Project number	9S8562
Client	Marine Current Turbines
Reference	9S8562/R/303519/Edin

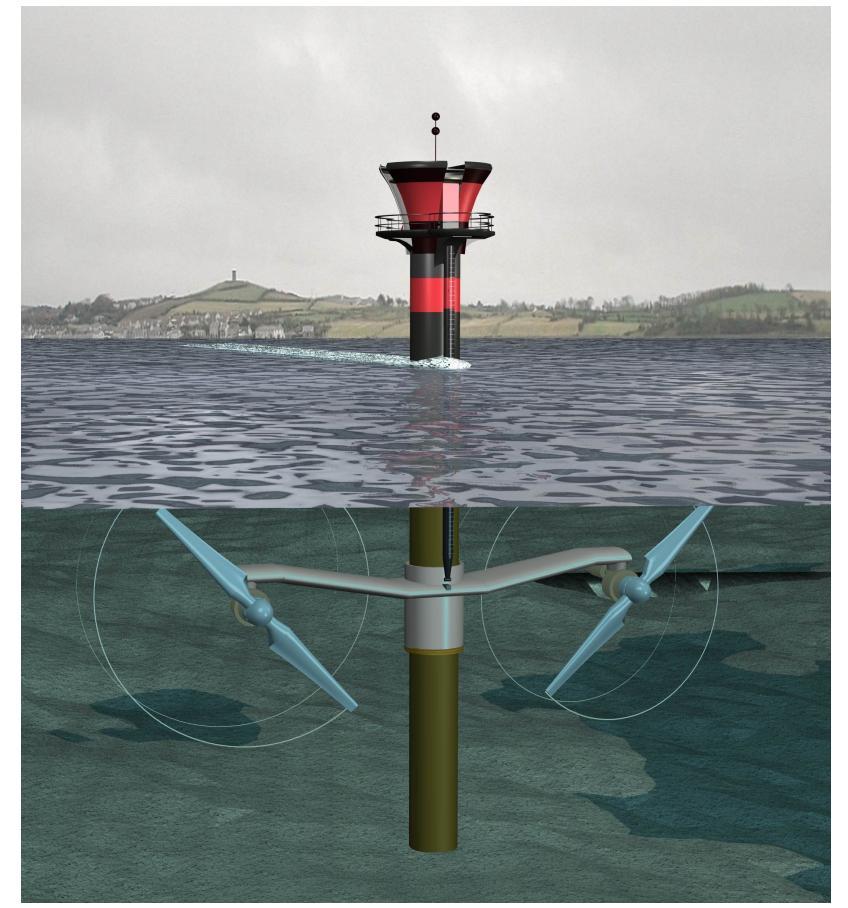
Figure 1 The SeaGen turbine, Strangford Lough, Northern Ireland.

The top of the pile is circa 9m above the average sea level, Figure 1. The twin rotors will begin to generate electricity once the tide runs faster than 1m/s. At a predetermined maximum tidal speed the rotors start to pitch to limit the maximum rotational speed to 14 RPM, resulting in a peak rotor tip speed of circa 12m/s.

Figure 1 shows the original SeaGen monopile installation concept which was varied in February 2008. The actual installation foundation is a four footed structure circa 18m and 12m dimensions rectangular in footprint, each corner of the foundation is supported on a circa 1m diameter pin pile. The whole bottom of the structure is above the seabed by circa 2m. Thus the revised installation has a lower footprint on the seabed.

SeaGen is a free stream tidal energy device that converts energy from tidal flow into electricity. SeaGen comprises twin 16m diameter rotors connected to a generator through a gearbox, with a rotor system supported on the end of a cross beam. The cross beam in turn is supported by a 3m diameter pile. The cross beam can slide vertically up and down the pile to allow access to the rotors, generator and gearbox for servicing and inspection, thus minimising the requirement for diver intervention.

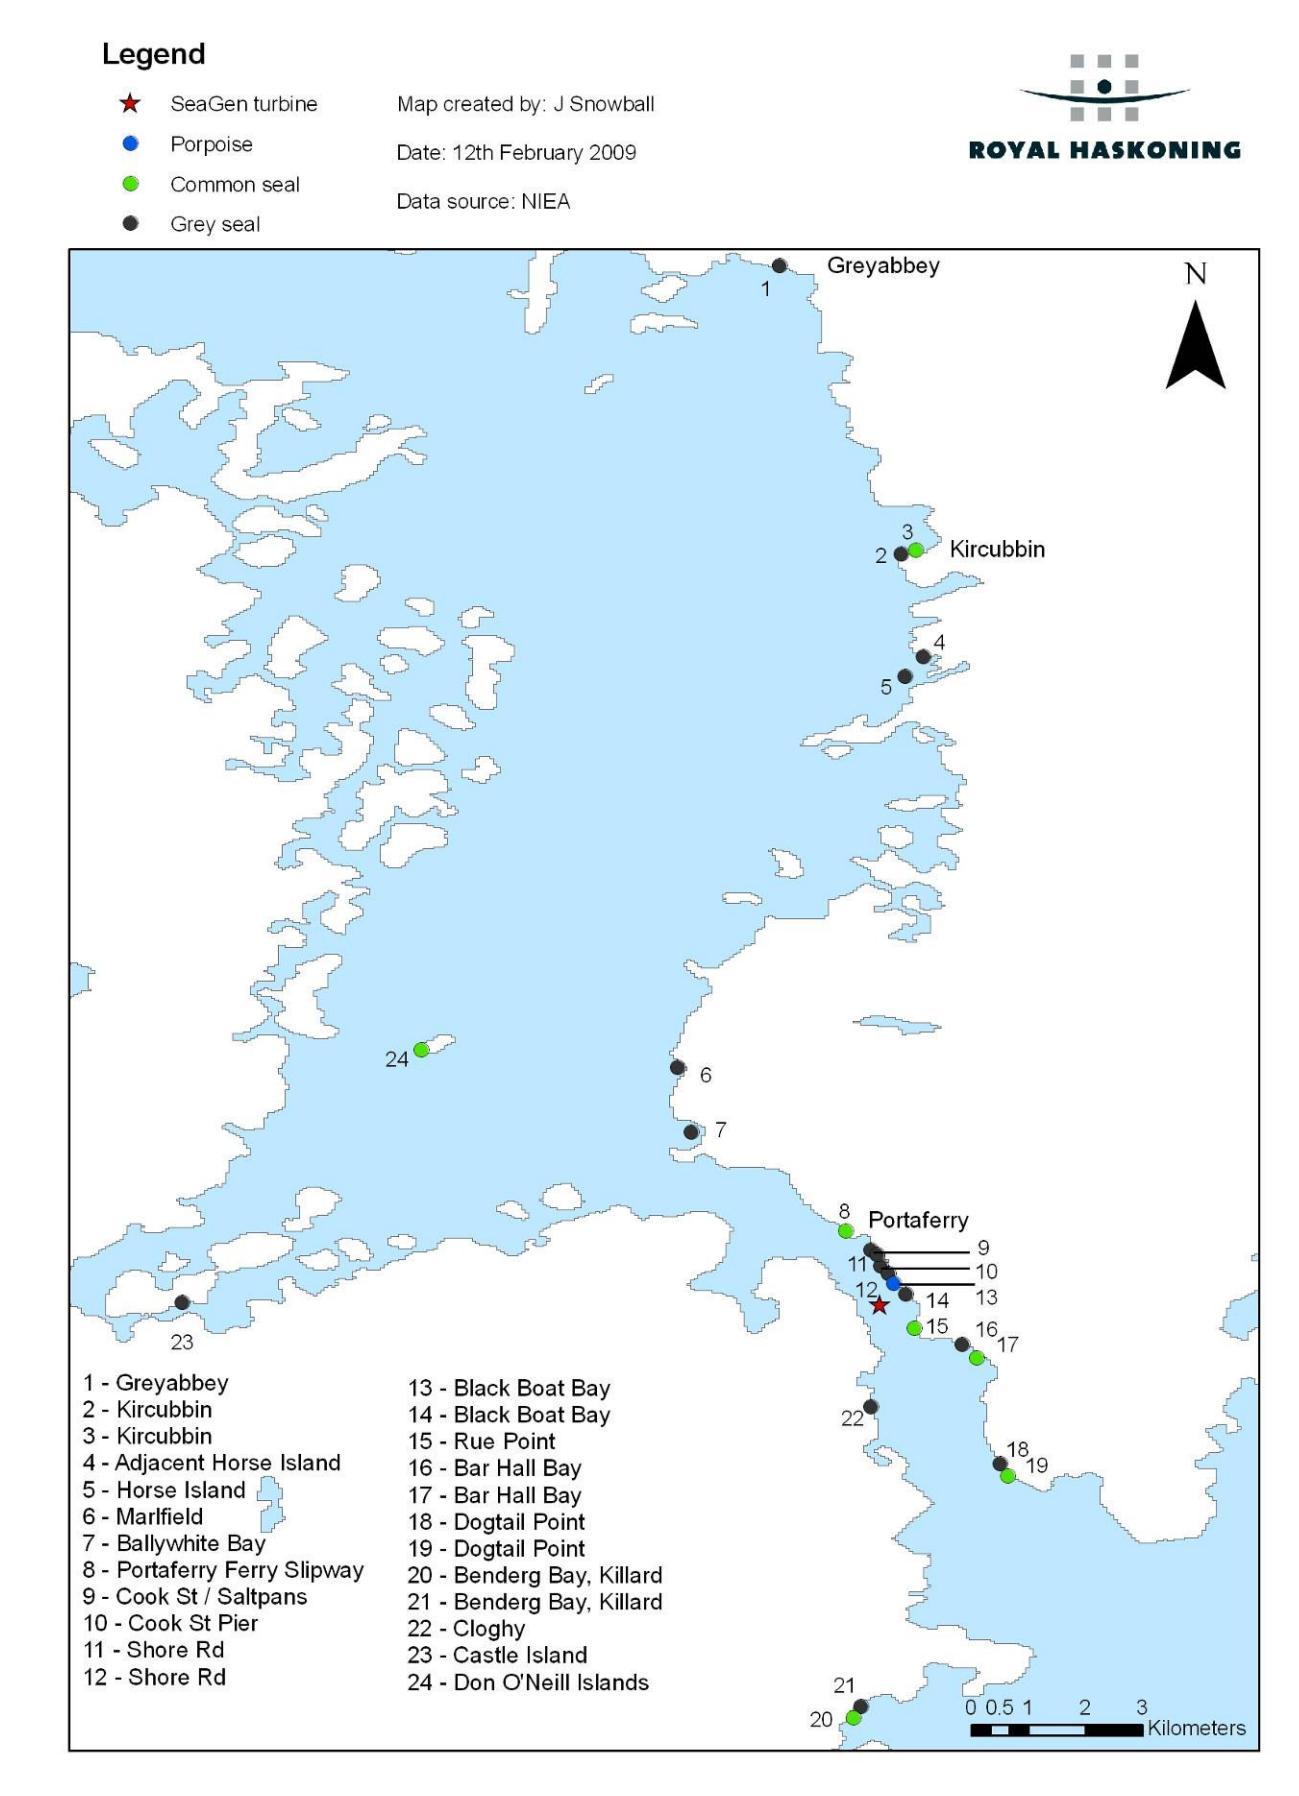
Figure 2 Marine mammal carcasses found inside Strangford Lough or on the Co. Down Coast between Cloghy and St. Johns Point between July 2008 and January 2009. Data source: NIEA

Table	12.3	Marine	mamma	l carcasses	found	inside	Strangford	Lough	or	on	the	Co.	Down	Coast
betwee	en Clo	oghy an	d St. Johr	ns Point betw	ween Ju	ly 200	8 and Janua	ary 2009). Da	ata	soui	rce: l	NIEA

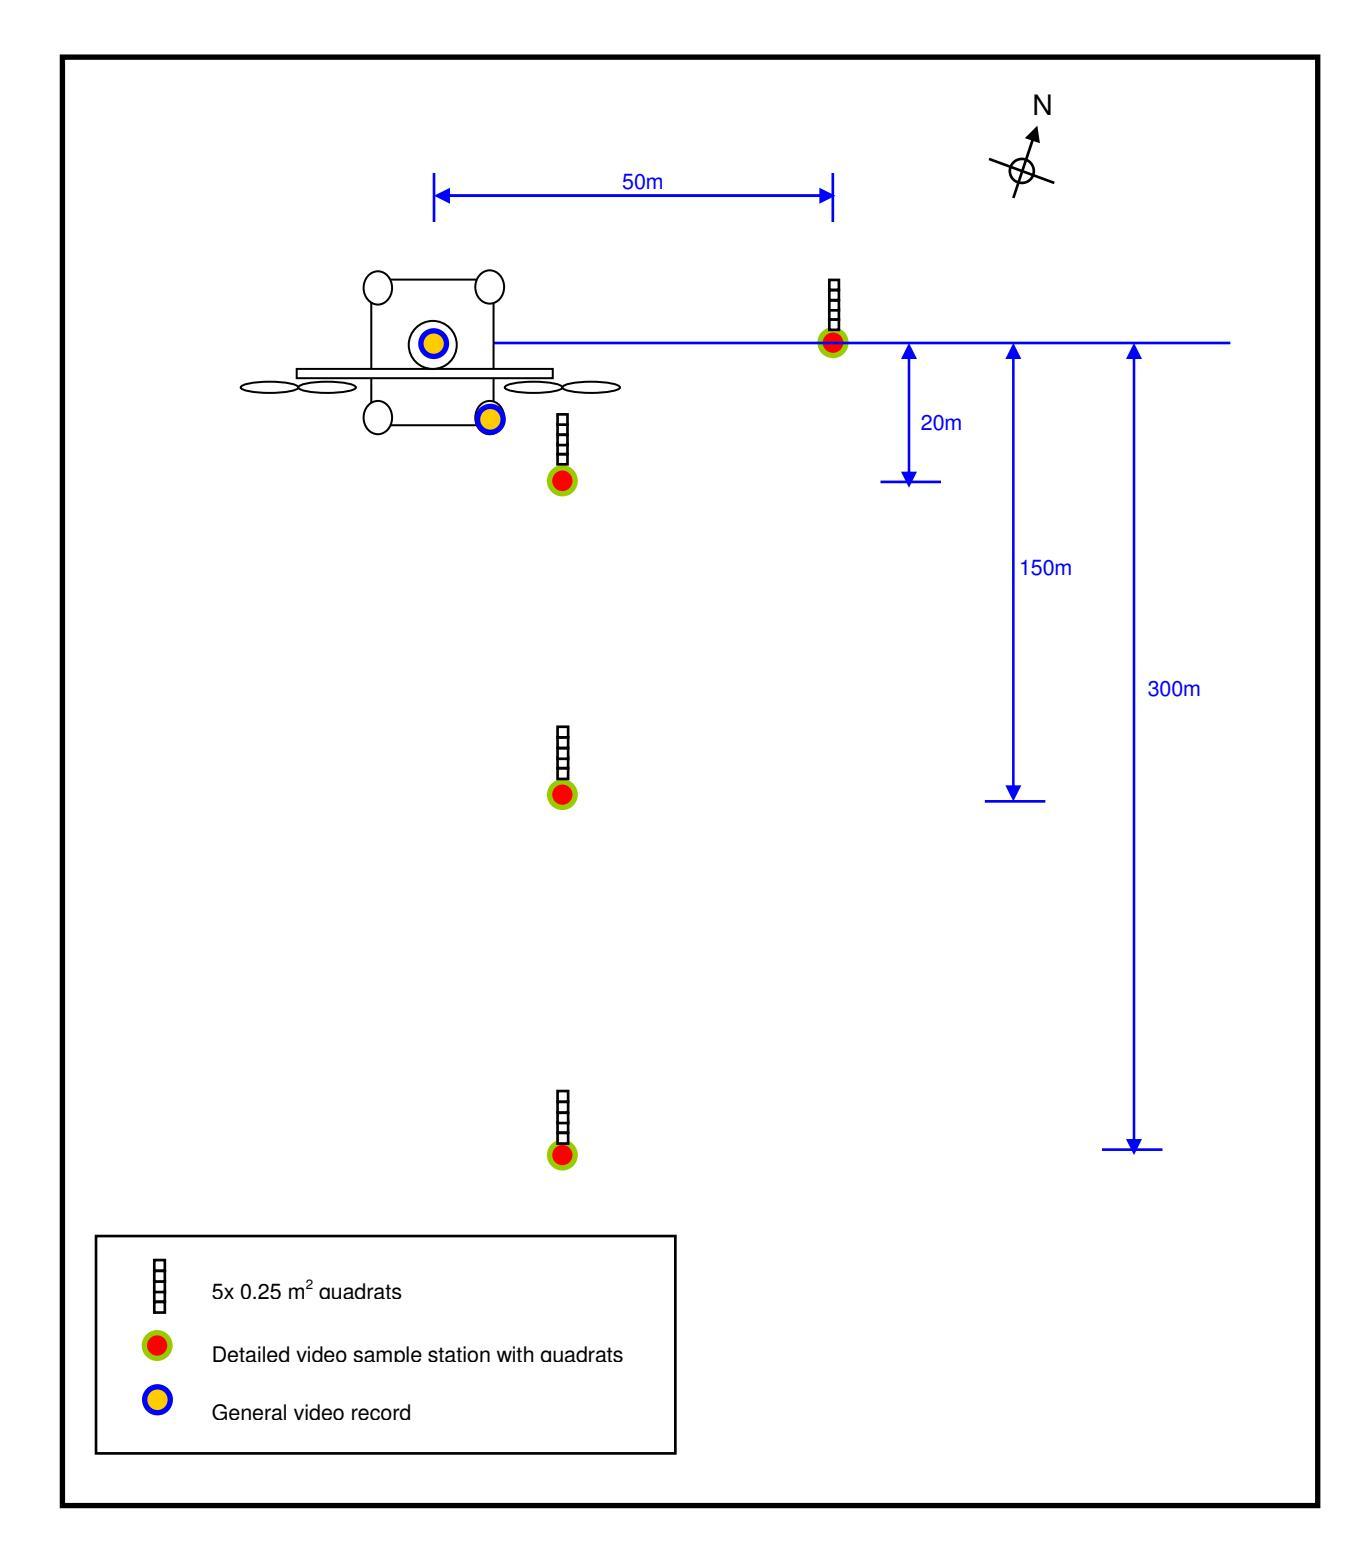
Stations (i) and (ii) have been selected as representative stations for possible turbine structure impacts. Station (iii) has been selected as a proxy to monitor the impact of the four anchor points. Previously obtained video has established that this station is likely to be the most vulnerable to physical damage as it contains a dense epifaunal community of sessile and long-lived species.

At each of these stations a diver obtains no less than 30 seconds of video footage within a 2m range of installation structures (where present) taking care to include obvious non-natural effects. For station (i) an area $2m \times 2m$ (depending on visibility) is documented. A direction which best represents the dominant seabed community is selected and noted by the diver and a slow video sweep of not less than 90° (from left to right) and taking not less than 30 seconds is made.

Figure 1. Schematic showing video sampling stations (not drawn to scale)

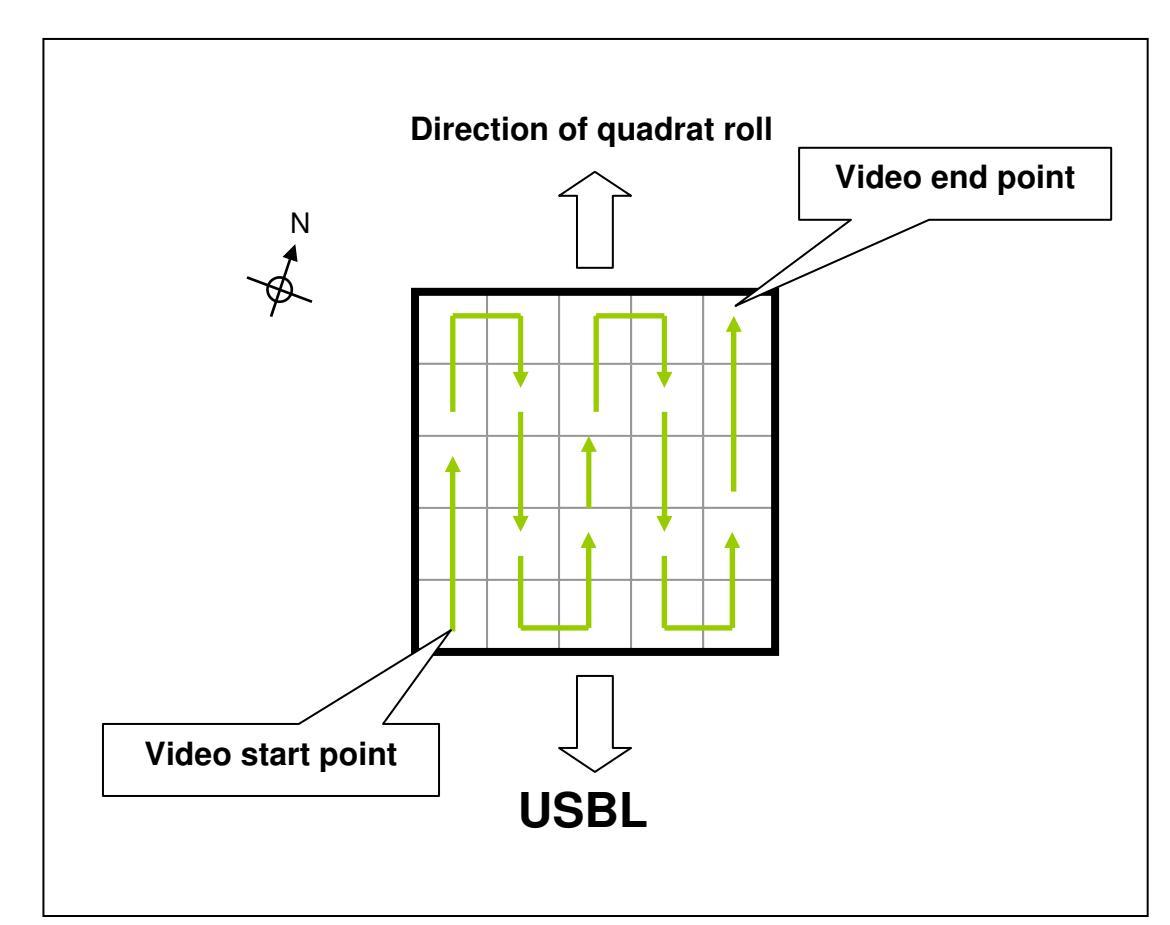
Once a direction has been selected and noted, five adjacent quadrats are recorded by rolling the quadrat in the designated direction. Each of the five quadrat placements require three video sequences to be taken:

Figure 2. Video sequence orientation and direction of successive deployment of 0.5m x 0.5m quadrat.

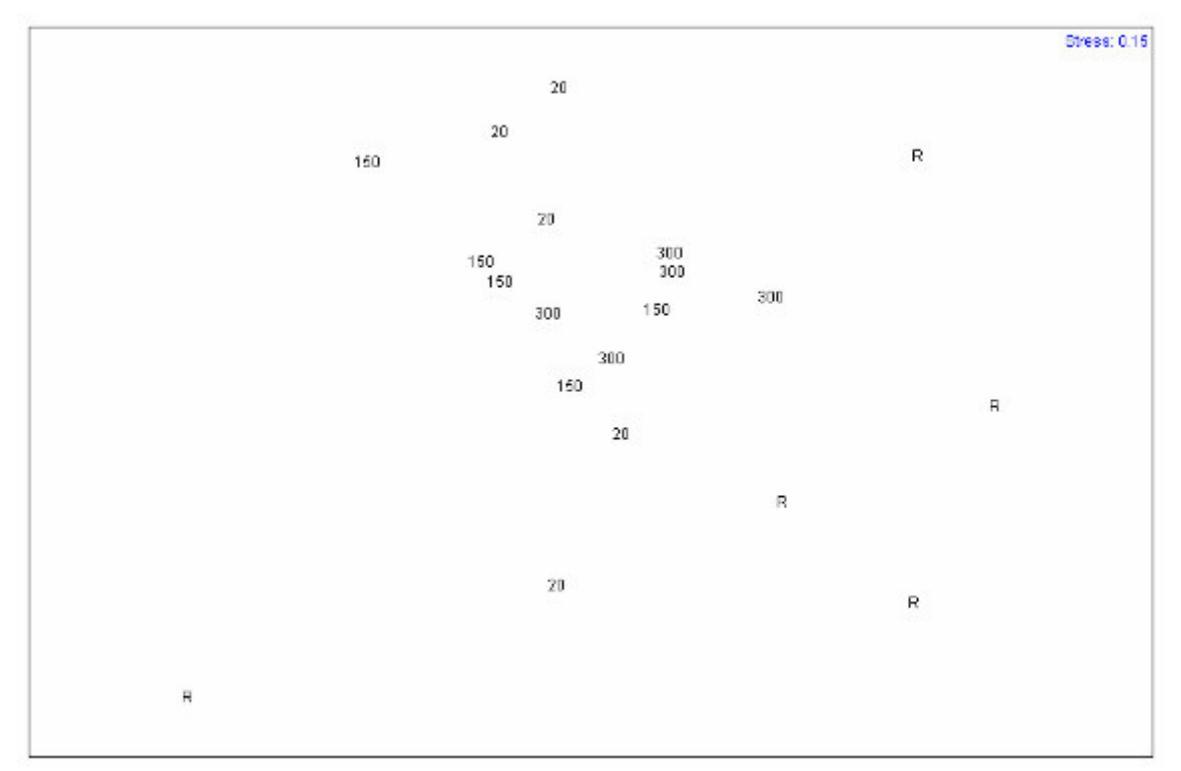
Multi-dimensional Scaling (MDS) ordination of the community data (Figure 3) confirmed that most stations were broadly similar, but indicates that there is a weak but significant difference, confirmed by use of the PRIMER Analysis of Similarities (ANOSIM) routine, separating the Reference stations from the others. Subsequent examination of the raw data suggests that there may be subtle overall species

abundance differences, but that the bulk of the segregation of the Reference samples is due to the wide variability between the Reference station quadrats.

Figure 3 Non-Metric Multi-dimensional Scaling (MDS) ordination of all pre-installation video quadrats. Abundance data are standardised and arcsine transformed. (Stations indicated as follows: R = Reference, 20 = 20 m, 150 = 150 m, 300 = 300m). The distance between any two station numbers indicates how similar, in terms of species and abundance, they are. Shorter distances indicate greater similarity, more distant quadrat samples indicate greater dissimilarity.

The slight Reference station dissimilarity, while unfortunate, is a problem commonly encountered when establishing marine monitoring programmes. The assignment of suitable 'control' or 'reference' areas of seabed for comparison with potentially impacted areas is notoriously difficult, since the seabed is topographically complex and the associated habitats and biota will therefore be patchily distributed. This non-uniform distribution is likely to be reflected in relatively small samples such as the quadrats used here.

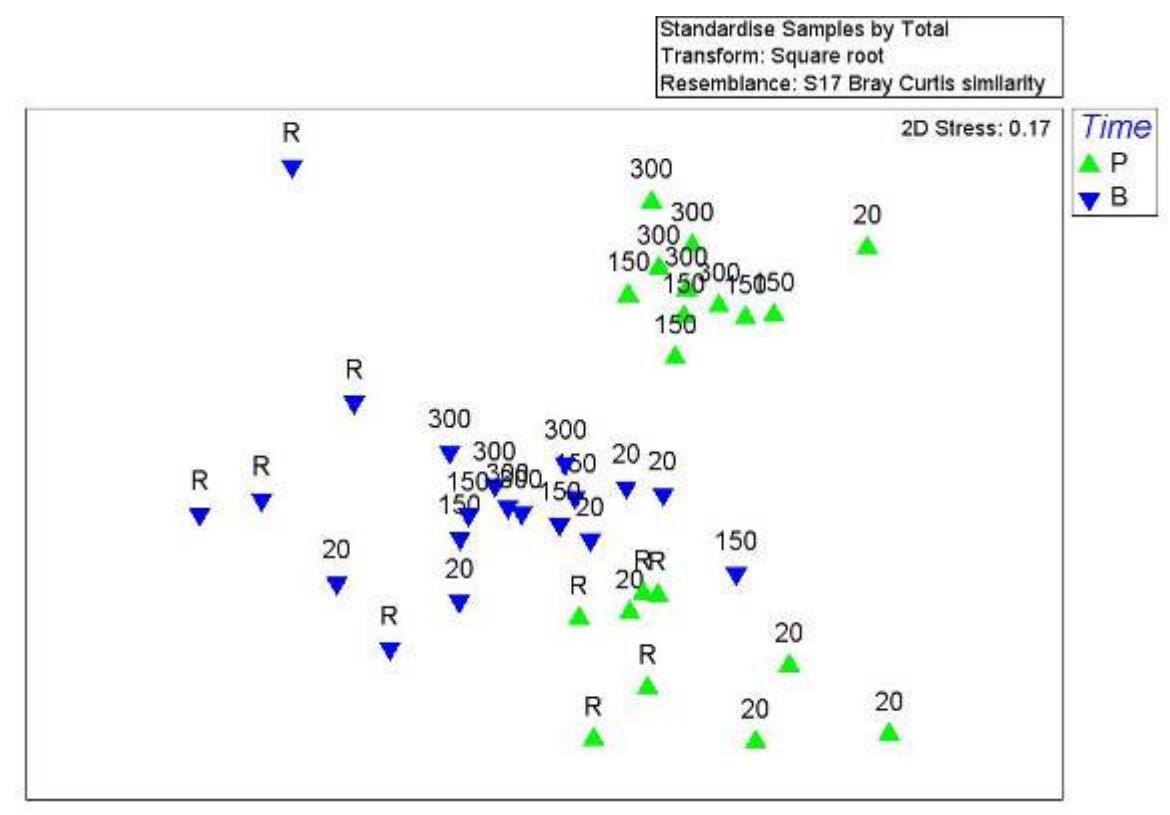
A MDS comparison of the pre- and post installation video samples show a degree of spatial segregation, providing an indication of possible biological community change between May and June of 2008 (Figure 4).

Figure 4 Non-Metric Multi-dimensional Scaling (MDS) ordination of pre- and post-installation video quadrats (B = before/pre-installation, P = post-installation). Abundance data are standardised and arcsine transformed.

The stress value, an indication of the reliability of the plot, is considered relatively high in Figure 4, suggesting that, although the broad segregations are probably valid, the detail should not be considered an accurate representation of station similarities.

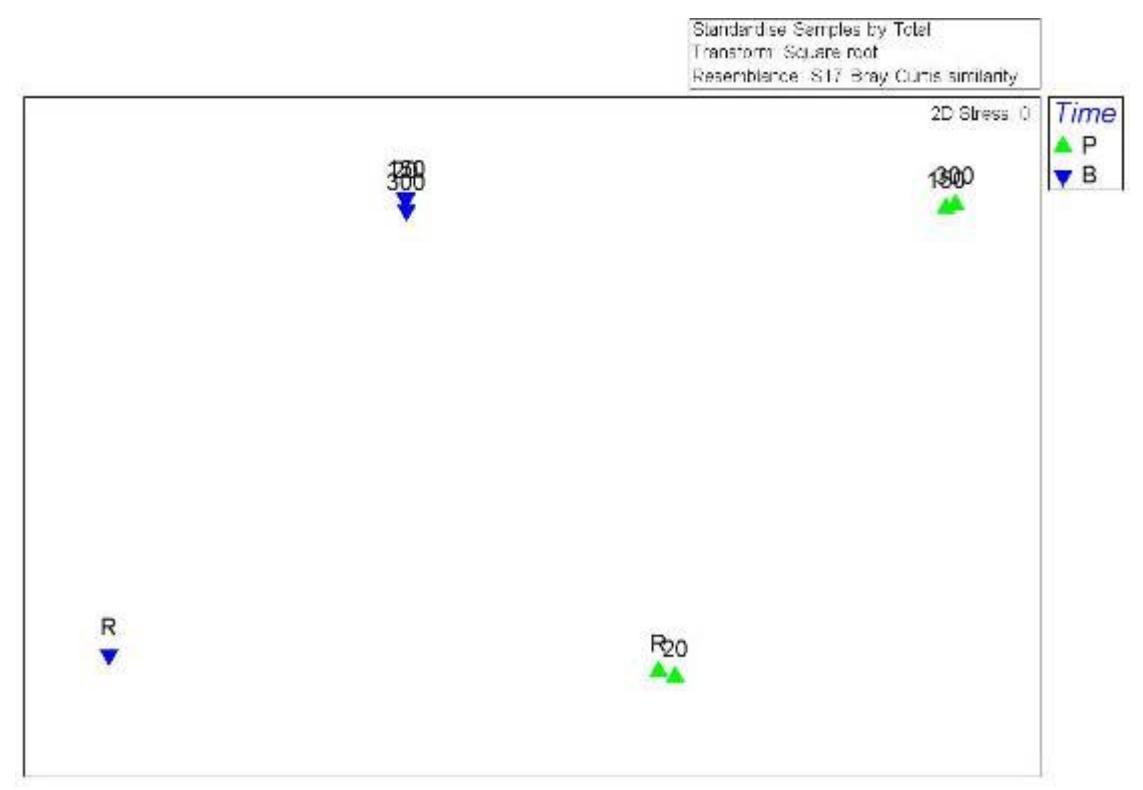
A MDS plot of the means of the species abundance for the five quadrats from each stations Figure 5 provide a considerably more reliable plot, confirming that there has been a statistically significant shift in biological community structure in **all** of the stations between March and July 2008.

Figure 5 Non-Metric Multi-dimensional Scaling (MDS) ordination of mean species (five quadrats) abundance for each sample station, pre- and post-installation sampling (B = before/pre-installation, P = post-installation). Abundance data are standardised and arcsine transformed.

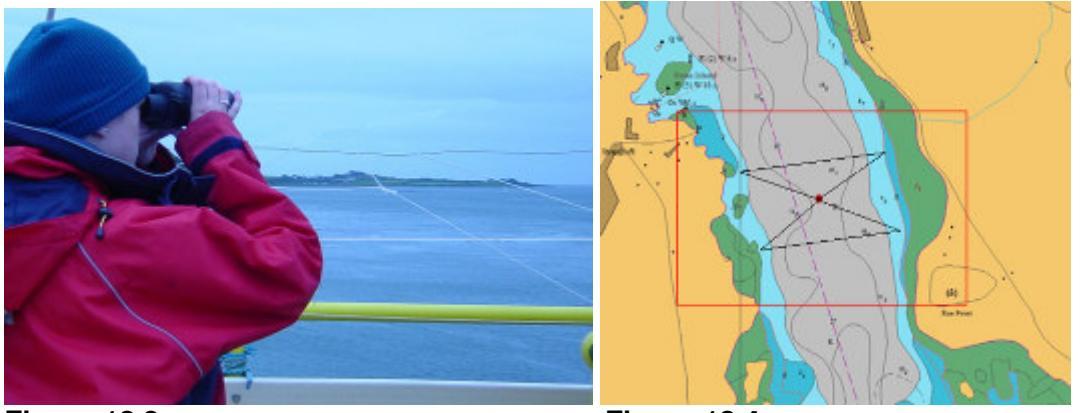
Figure 12.3

The application of a simple observational grid across the observer's field of view has allowed the survey team to record the surface behaviour and travel patterns of marine mammals within 200m of the SeaGen turbine.

Figure 12.3: MMO looking upstream through observational grid (the grid can be adjusted depending on the surveyors height and state of tide), Figure 4.2: approximate coverage of observational grid
